**COMPREHENSIVE MOTOR VEHICLE SERVICES AND
CONSULTING
MOTOR VEHICLE FORENSIC ANALYSIS
REPORT**

CMVSC-18-IA-245

-- In the Matter of the Death of Edson Thevenin --

INVOLVED DYNAMIC SUBJECT VEHICLE: 2000 Honda Civic EX Two Door Coupe

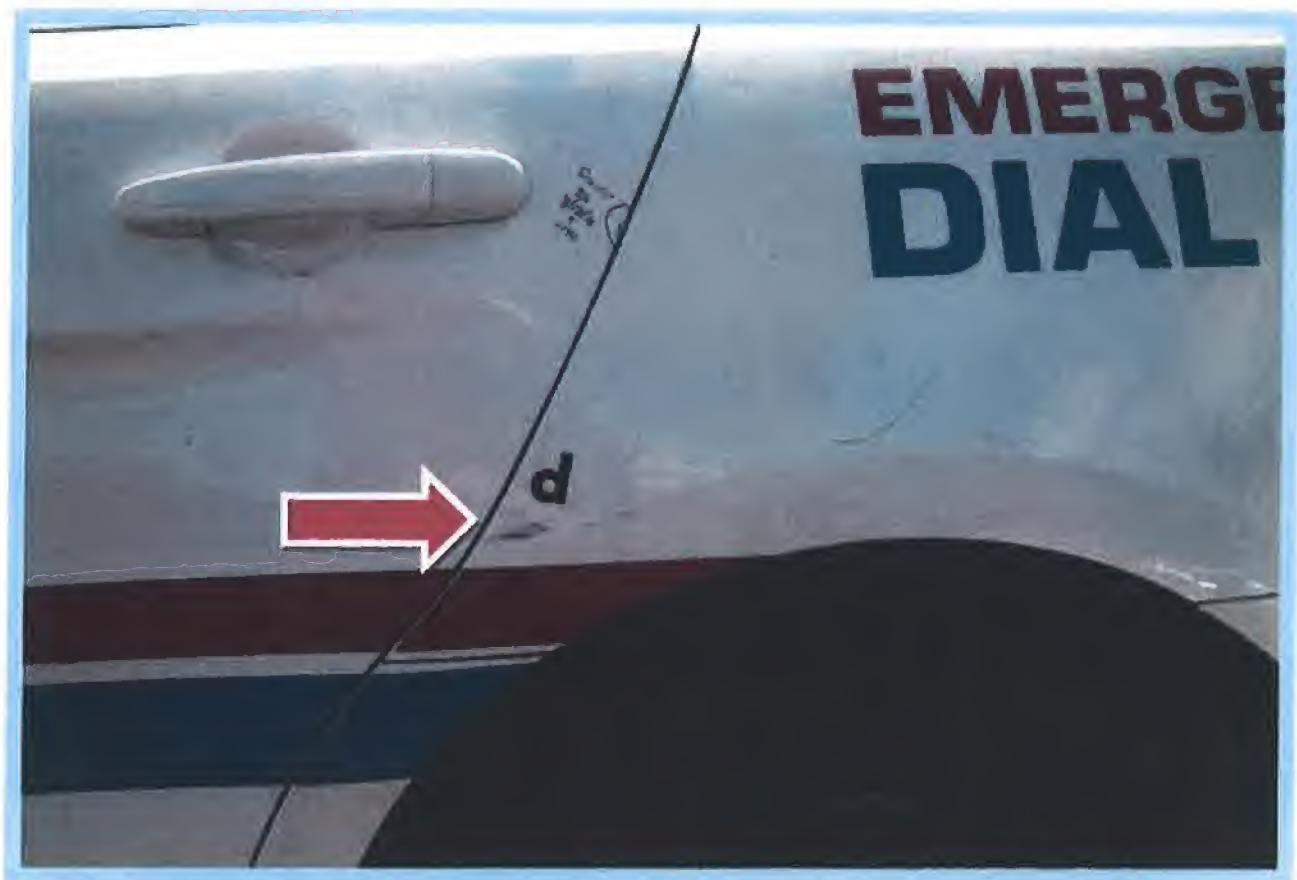
4) **Location of Damage:** Left Rear Quarter Panel, Forward Upper Wheel Well Area.

Description of Damage: Striations/scuffing/transfer.

Image No. 35 This photograph depicts the described damage present at the left rear quarter panel upper dog leg area of the 2013 Ford Taurus. Note the obvious scuffing/transfer (Red Arrow).

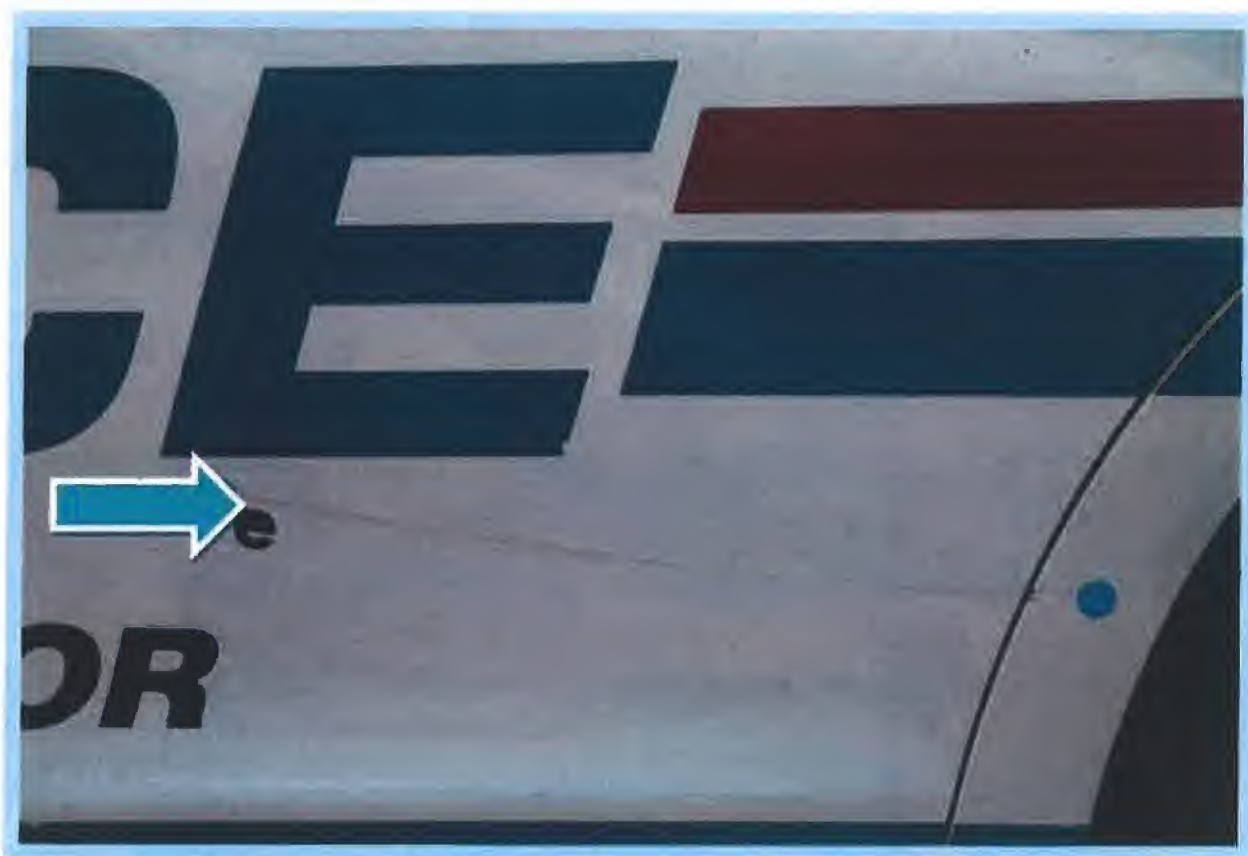
5) Location of Damage: Left Rear Door Panel, Lower Rear into Dog Leg.

Description of Damage: Striations/scuffing/transfer.

Image No. 3b. This photograph depicts the described damage present in the left rear quarter panel of the 2017 Ford Taurus. Note any obvious scuffing/transfer (Blue Arrow).

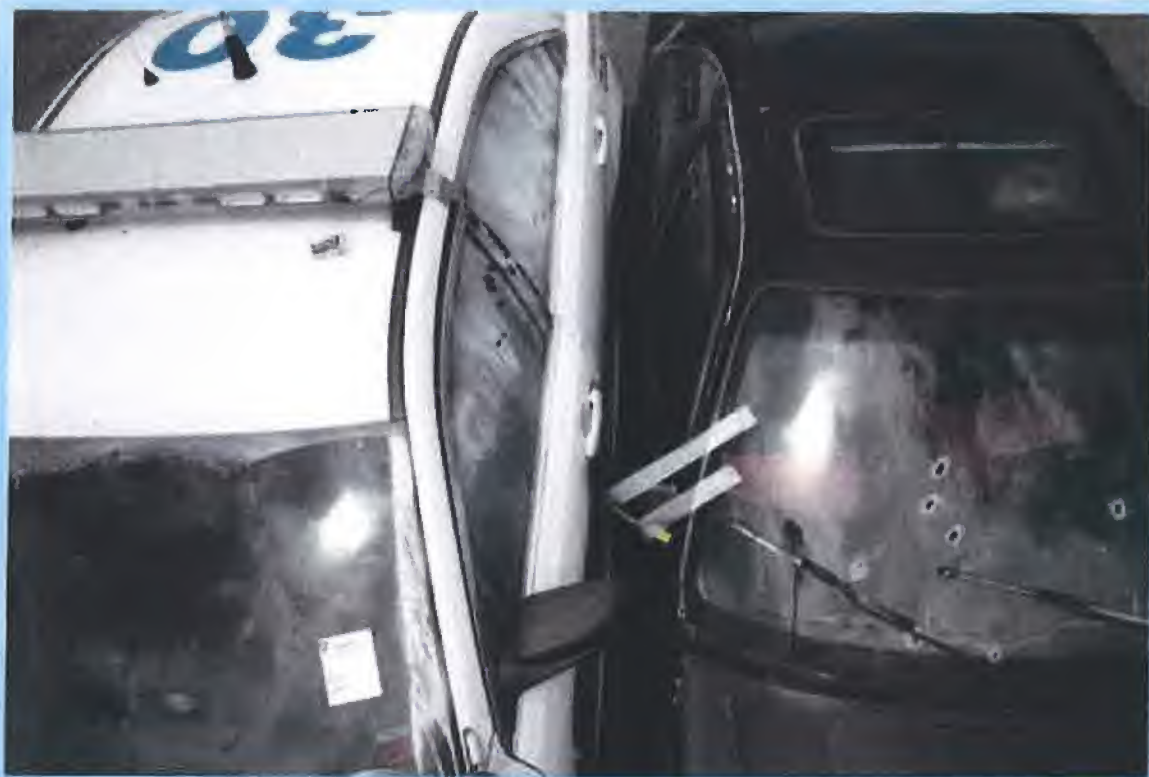
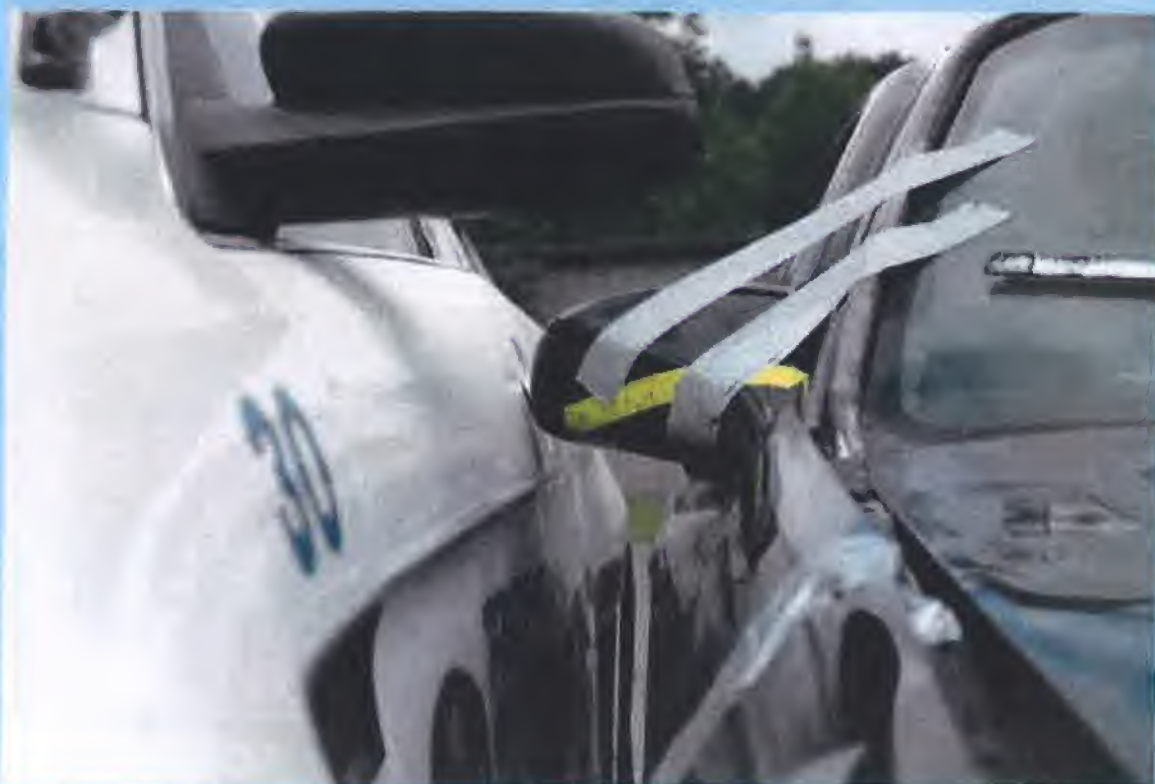
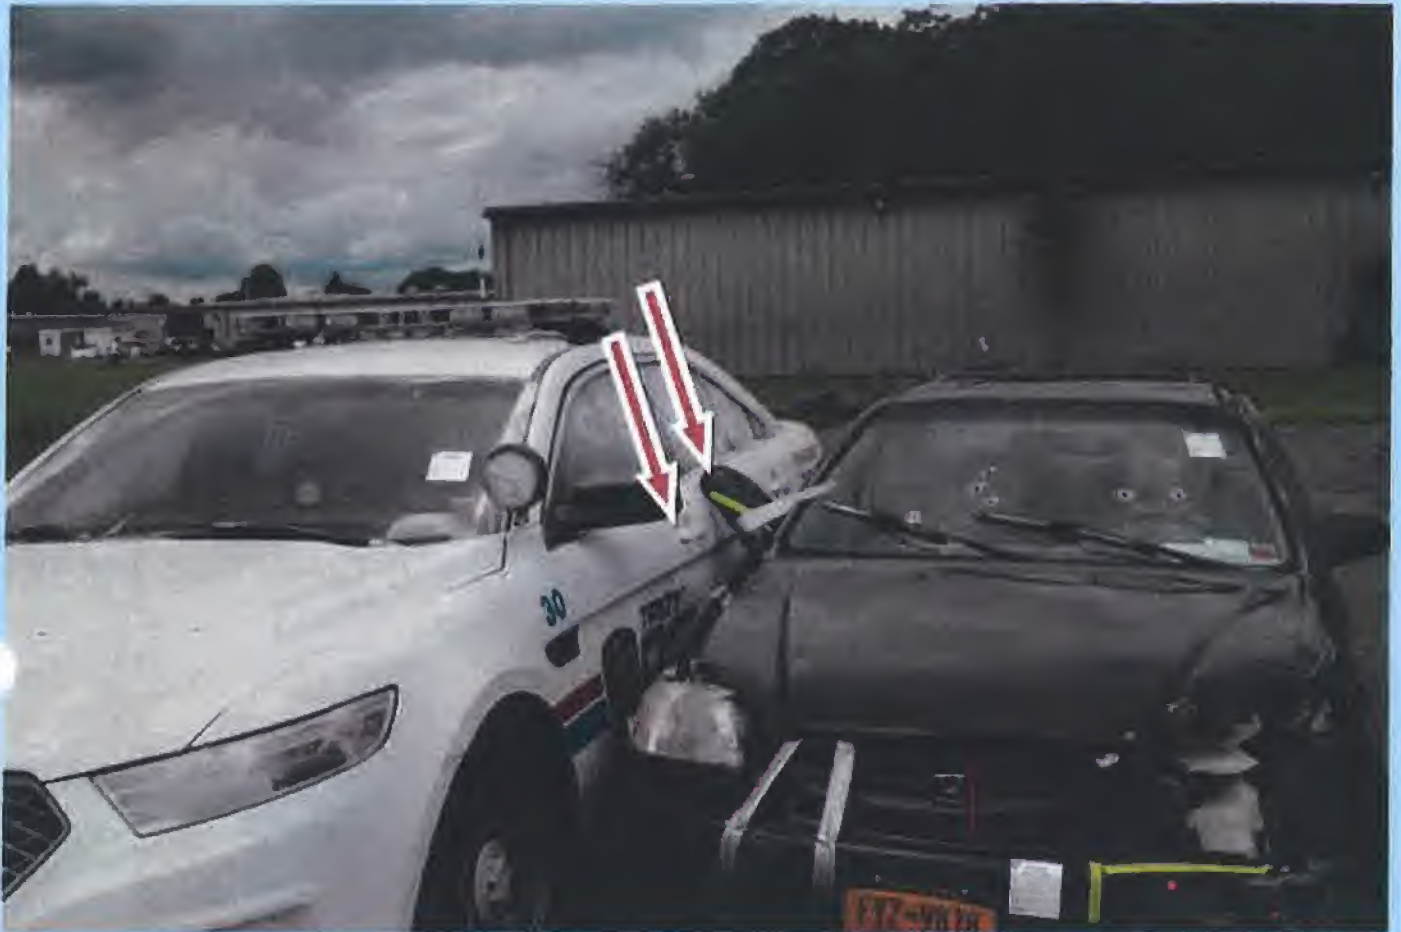
Images No. 37a, 37b, & 37c. These photographs (previous page and above) depict the forensic, non-laps of the staff transfer marks of the 2013 Ford Taurus with the 2000 Honda Civic right outside rearview mirror prior to and during detachment. The Red Arrows denote areas of black smudges and scuffing present on the Ford Taurus.

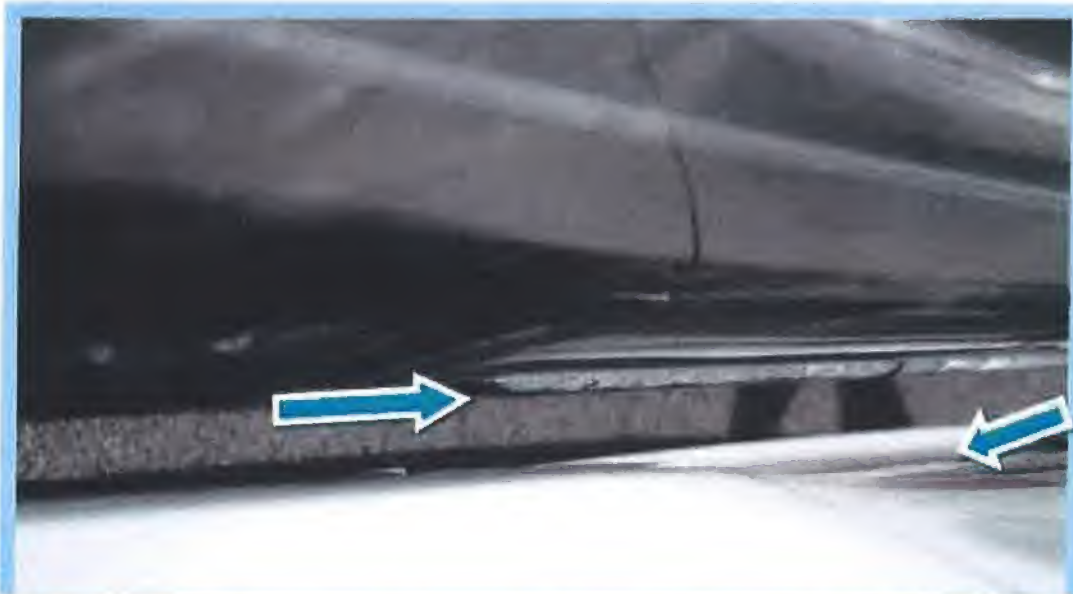
Image No. 39. The above photograph depicts the forensic matchup of the small transfer marks of the left rear exterior door panel of the 2013 Ford Taurus with the right rear exterior side guard molding of the 2000 Honda Civic. The blue arrows denote the approximate contact area.

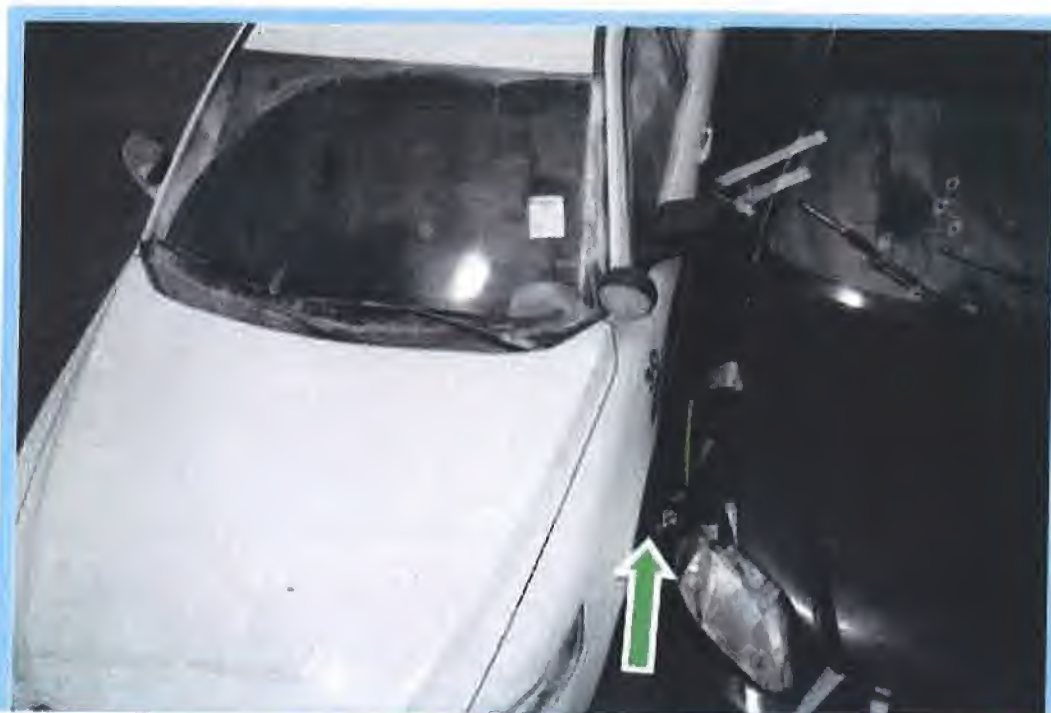
Image No. 40 The above photograph depicts the forensic matchup of the scuff transfer marks of the lower rear panel of the left front fender of the 2013 Ford Taurus with scuff transfer marks of the right side front bumper cover of the 2000 Honda Civic. The Green Arrow denotes the approximate contact event.

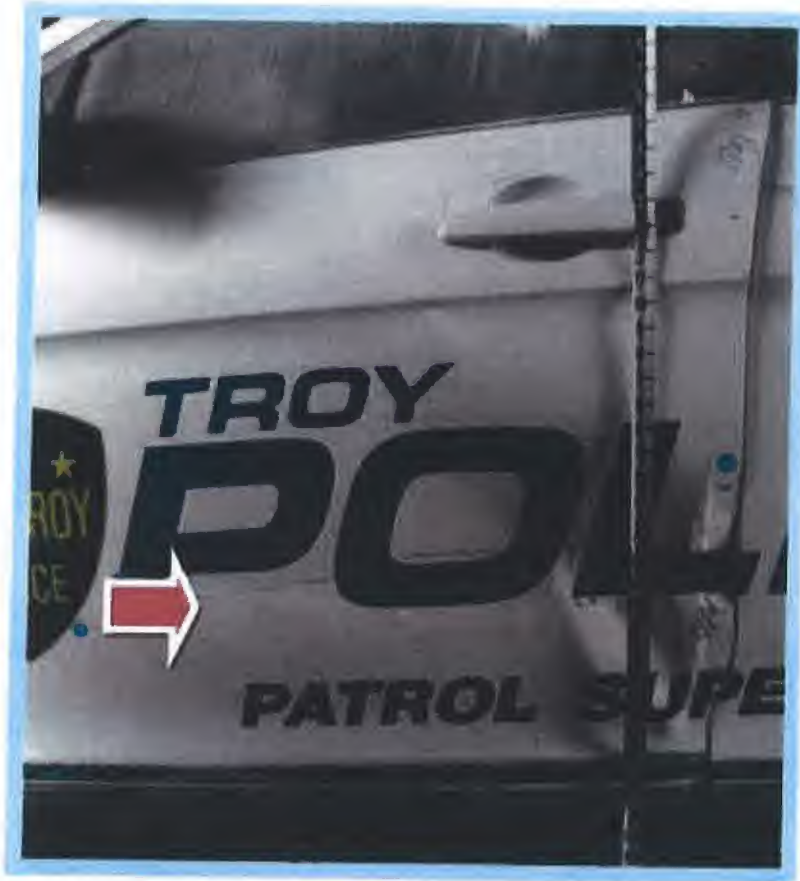
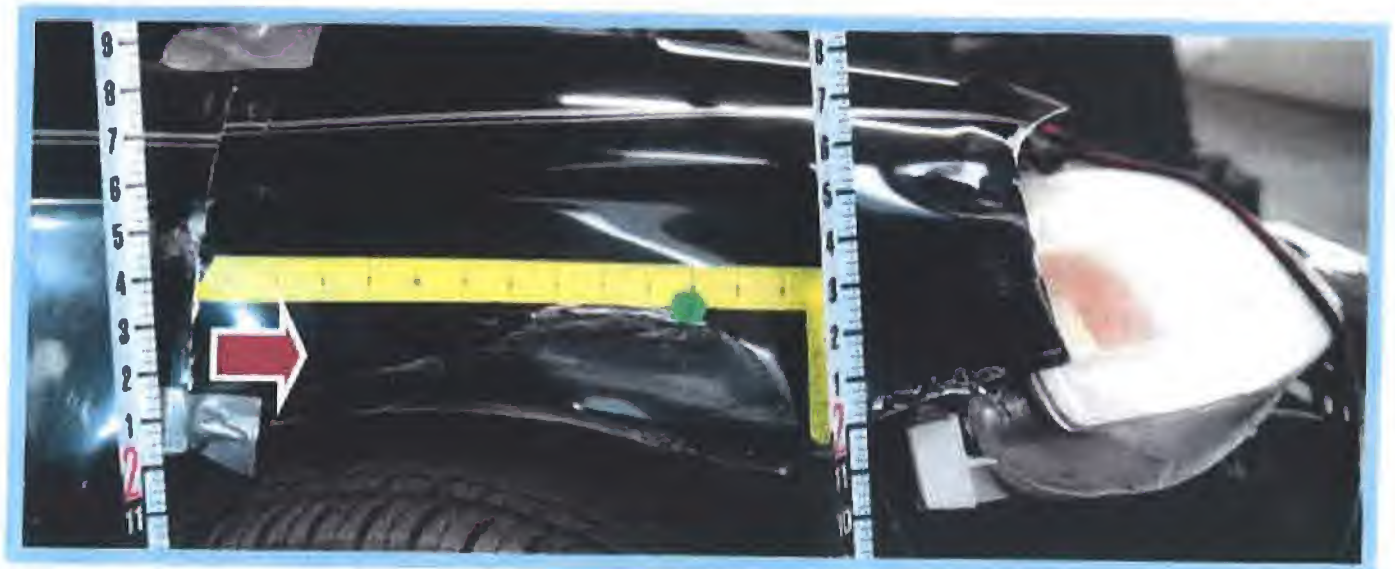
Images No 41a & 41b These photographs depict the described damage present at the left front outer door panel of the 2013 Ford Taurus and the right front outer fender panel of the 2000 Honda Civic. Note the matching scuffing transfer, as well as the height of the deformation damage resulting from forward sliding impact. The Red Arrows denote the direction of the damage with obvious increasing intrusion.

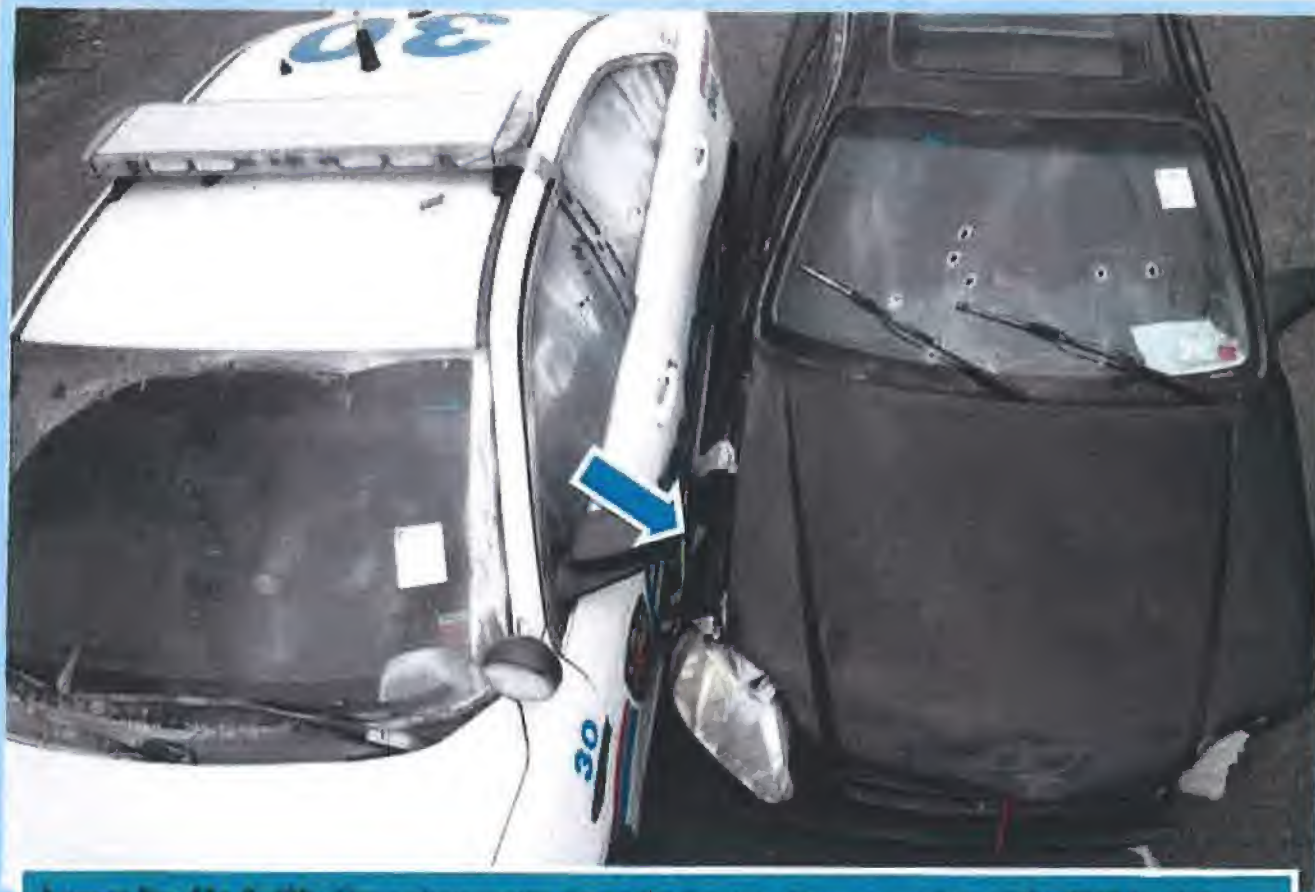
Images No. 42a & 42b These photographs depict the forensic damage matchup of the 2013 Ford Taurus left front door and 2006 Honda Accord right front fender. The blue arrows denote the matched contact areas of the two motor vehicles. The directional damage is consistent with the white Ford Taurus traveling at the faster rate of speed.

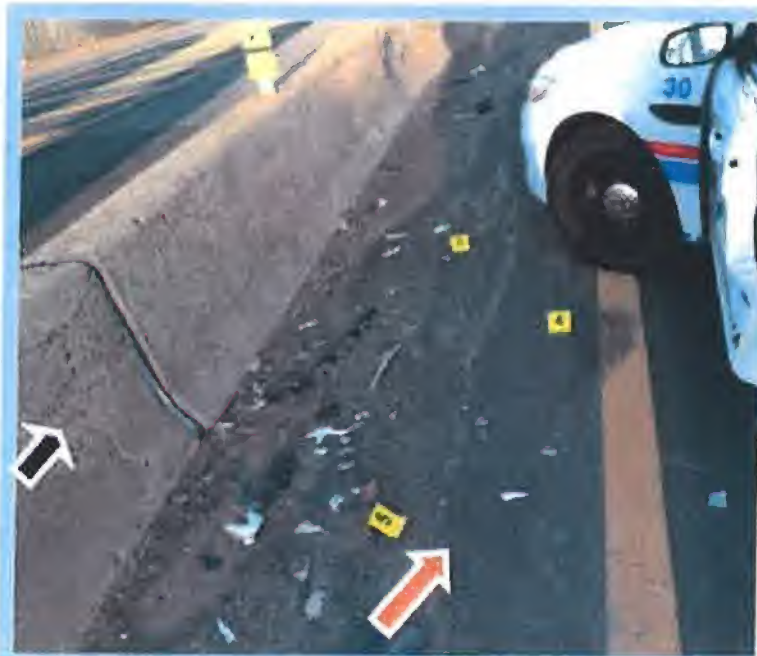
Image No. 46. This scene photograph depicts the wall mark of the sideways sliding right front end of the involved 2000 Honda Civic (Orange Arrow) resulting from forced westerly trajectory of the front of the vehicle along the concrete barrier due to the severity of the barrier impact. The Black Arrow designates the corresponding physical evidence of the left frontal area of the 2000 Honda Civic during impact trajectory in a westerly direction along the concrete barrier to ultimate stopped vehicle location.
